SERVICE INSTRUCTION

SI-24-01
Revision 0

TITLE: Ignition System Wiring Reconfiguration

Found Aircraft Canada Inc.

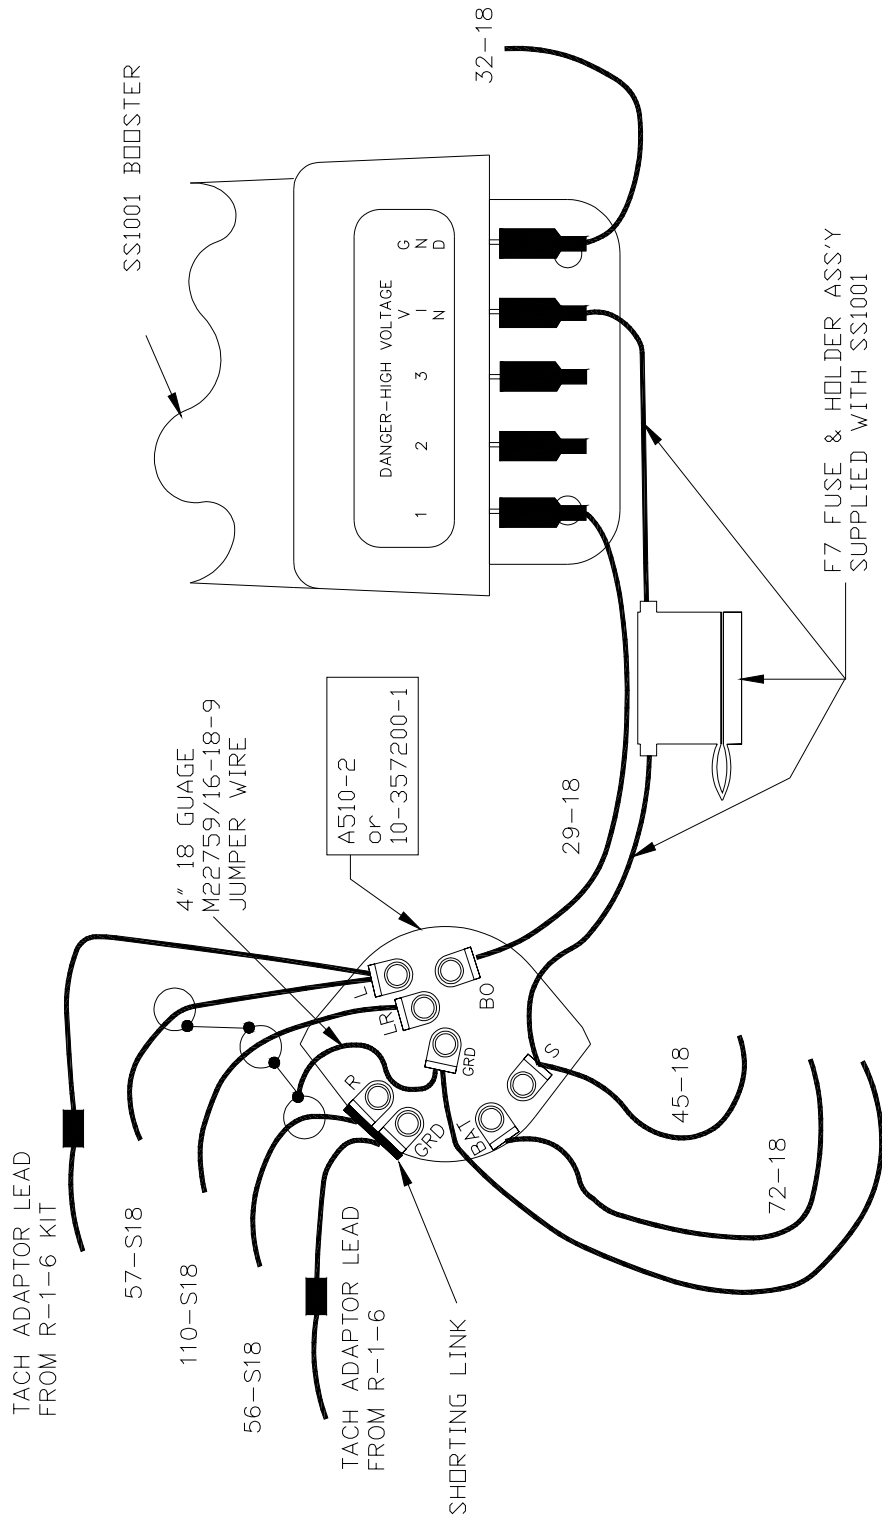
FIGURE 3 PRE-EXISTING IGNITION SWITCH WIRING

4. Figure 3 illustrates the current wiring arrangement. Note, the 10-357200-1 switch has an extra terminal, labeled “PR” and is not used.
5. The shields of wires 56, 57, 110 and the 4” jumper need to be disconnected from each other. They will remain connected at the magnetos.
6. Wire 110-S18 should be removed from terminal “LR”. The #6 ring tongue terminal should be removed. The exposed shielding may be trimmed at this time and cover with heat shrink or similar material. The spare terminal connector on Pin 3 of the
